**WEST VIRGINIA DEPARTMENT OF ENVIRONMENTAL PROTECTION  
WV/NPDES CONSTRUCTION STORMWATER PERMIT**

<b>FACILITY NAME:</b>	Raleigh County Elementary School			<b>REG. #</b>	<b>EXPIRE DATE:</b>
<b>PERMITTEE</b>	RALEIGH CNTY BD OF ED			WVR108335	1/3/2018 Extended: 6/30/2018
<b>ADDRESS/PHONE:</b>	Attn: ROD LIVELY, DIR OF FAC & MAIN 151 CRANSTON DR BECKLEY, WV 25801 3042564565				
<b>LOCATION:</b>	37° 43' 31.9" N, 81° 15' 16.30" W			<b>Entry Date/Time:</b>	5/1/2018 0925
<b>COUNTY:</b>	Raleigh			<b>Exit Date/Time:</b>	5/1/2018 1130
<b>Site Representative /Phone</b>	Johnny Blair-Radford & Radford Brett Hunsucker- PCS			<b>PHOTOS</b> <input checked="" type="checkbox"/>	
<b>CO-PERMITTEE:</b>				<b>ADDRESS:</b>	
<b>SITE OPERATOR:</b>	Radford & Radford Inc.			<b>ADDRESS:</b>	860 Ragland Road, Beckley WV 25801
<b>PERMITTED ACREAGE</b>	15	<b>WEATHER:</b>	Clear	<b>LAST INSPECTION:</b>	n/a
<b>RECEIVING STREAM(S)</b>	Shockley Branch/Camp Branch/Marsh Fork/Big Coal River				<b>NOV: 1</b>
<b>Regular Mail</b> <input type="checkbox"/> <b>Certified Mail</b> <input checked="" type="checkbox"/>		<b>Tracking #</b>

STATE OF WEST VIRGINIA  
Department of Environmental Protection  
Environmental Enforcement

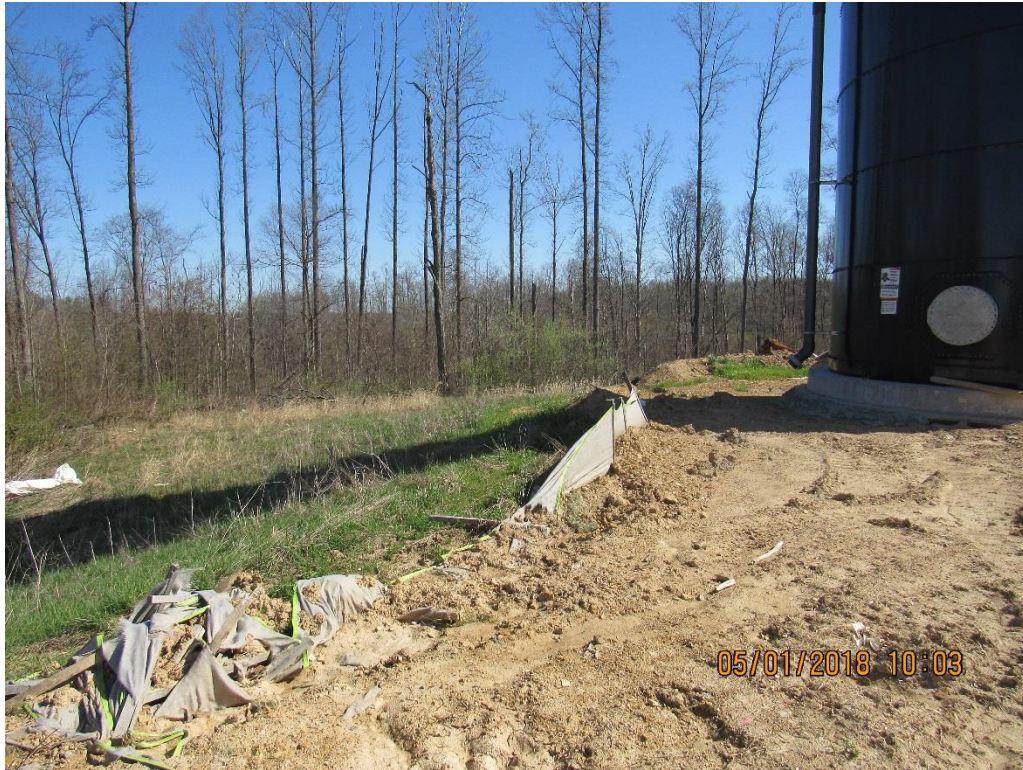
- 1. Perimeter Fence was in serious disrepair throughout the project area. Observed silt fencing with broken stakes, pushed over from sediment, holes within fencing in 2 separate locations, under cut with erosion gullies, material stacked upon fencing, debris stored against fencing, loose fencing, inappropriate breaks in fencing allowing sediment laden water to leave the site without going through an appropriate device. (Photos 1-11)

- **Section D.1. - Permittee has failed to properly operate and maintain all systems of treatment and controls- perimeter fence needs maintenance, diversion ditch needs maintenance, materials are stored on/against silt fence, and silt fence has holes in 2 separate locations. (Photos 1-11)**

Photo 1: Silt fence needs maintenance.

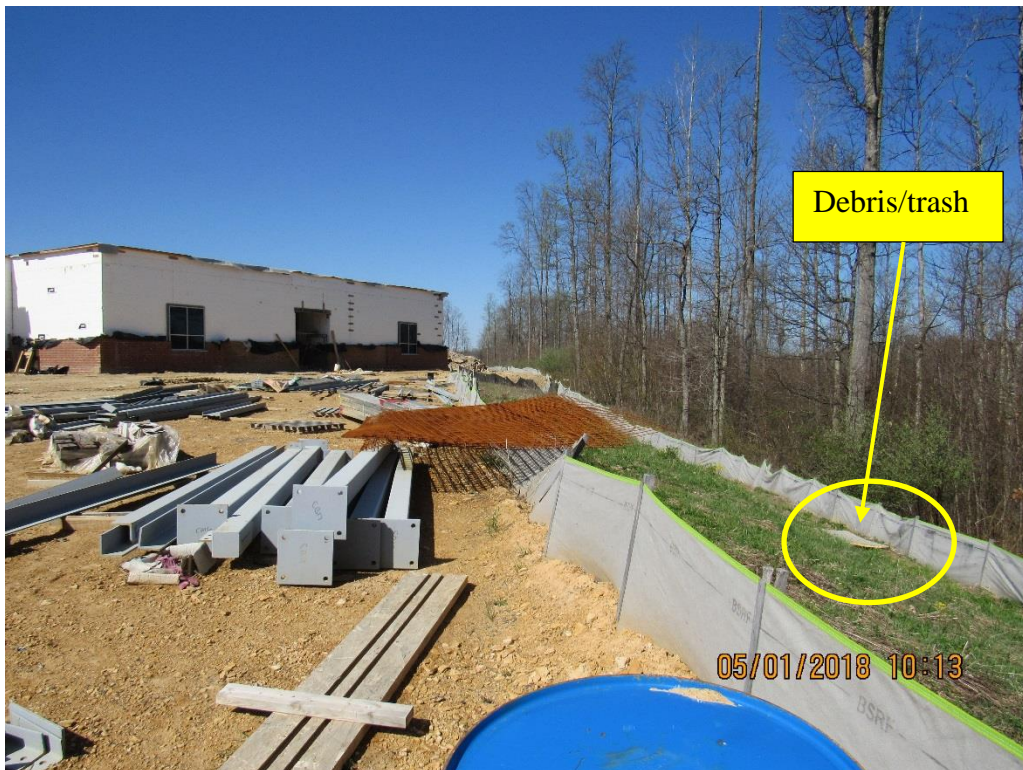
- 9. Housekeeping- site has trash and construction debris scattered throughout. Trash was observed embedded into soil, blown across perimeter fence, pushed against perimeter fencing and within diversion ditch. Dumpster was on-site (Photos 2, 4, 6-11, & 22-24)

- **Section G.4.d.1.B.- Permittee has failed to maintain a clean and orderly project site- trash was observed at multiple locations, including against silt fence, partially buried, and beyond area of disturbance. (Photos 2, 4, 6-11, & 22-24)**

Photo 2: Material stored on silt fence knocking it over and debris/trash beyond first layer of silt fence.

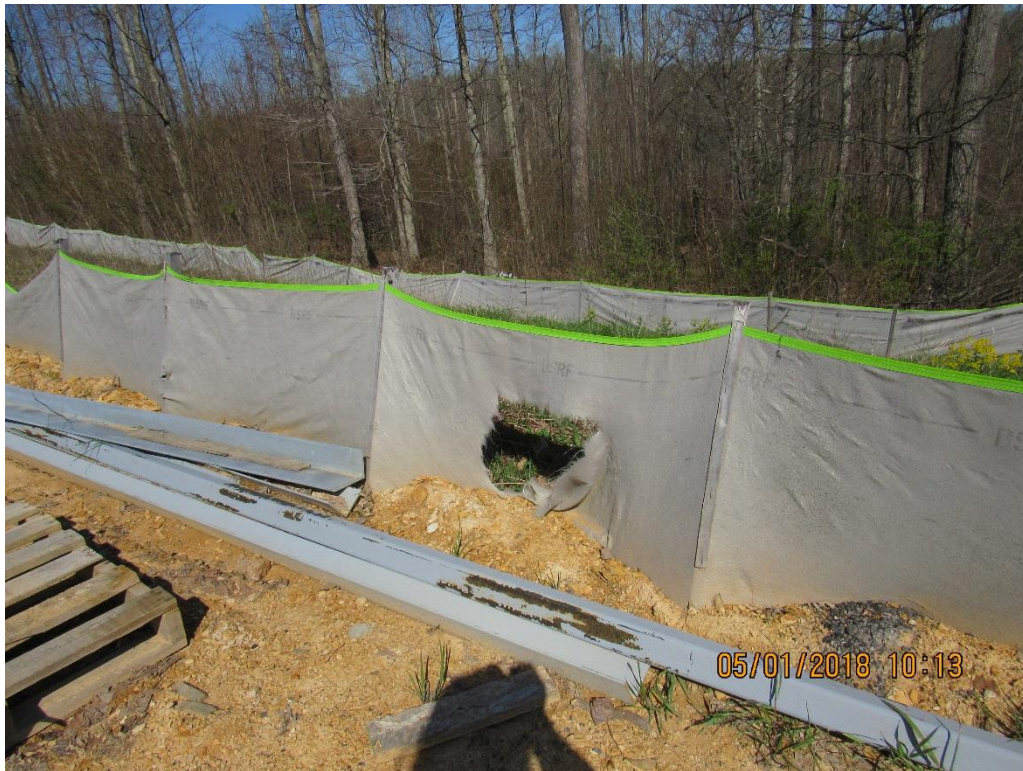
Photo 3: 1 of 2 holes observed in silt fence.

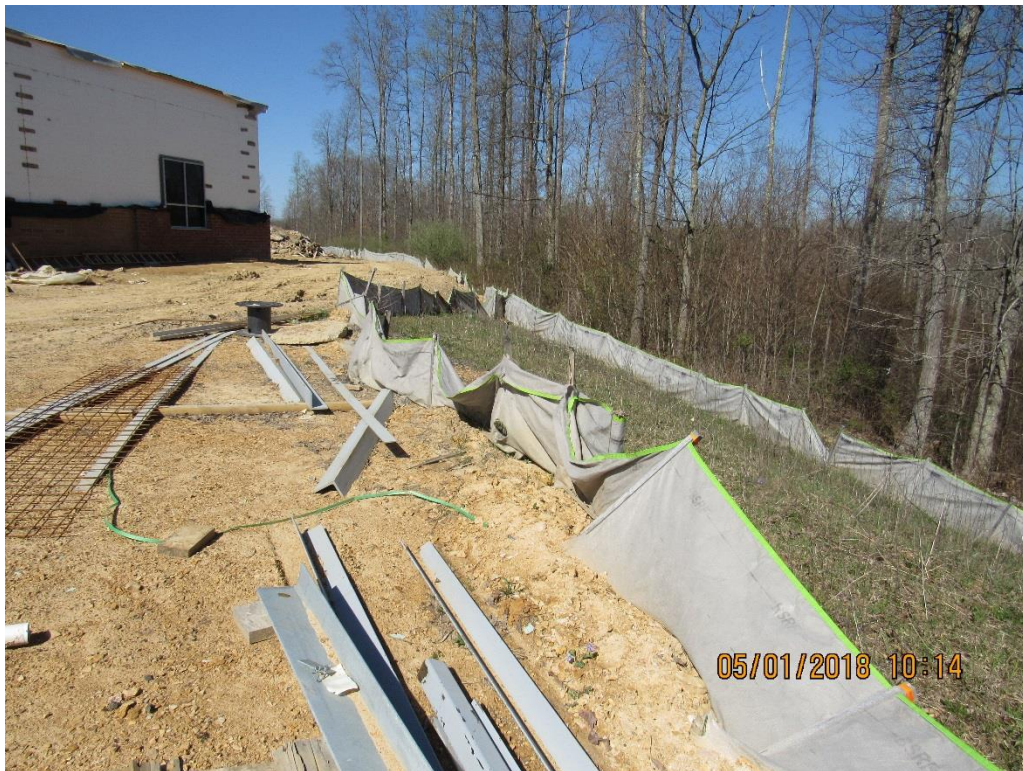
Photo 4: Silt fence needs maintenance and debris/trash is randomly laying over site.

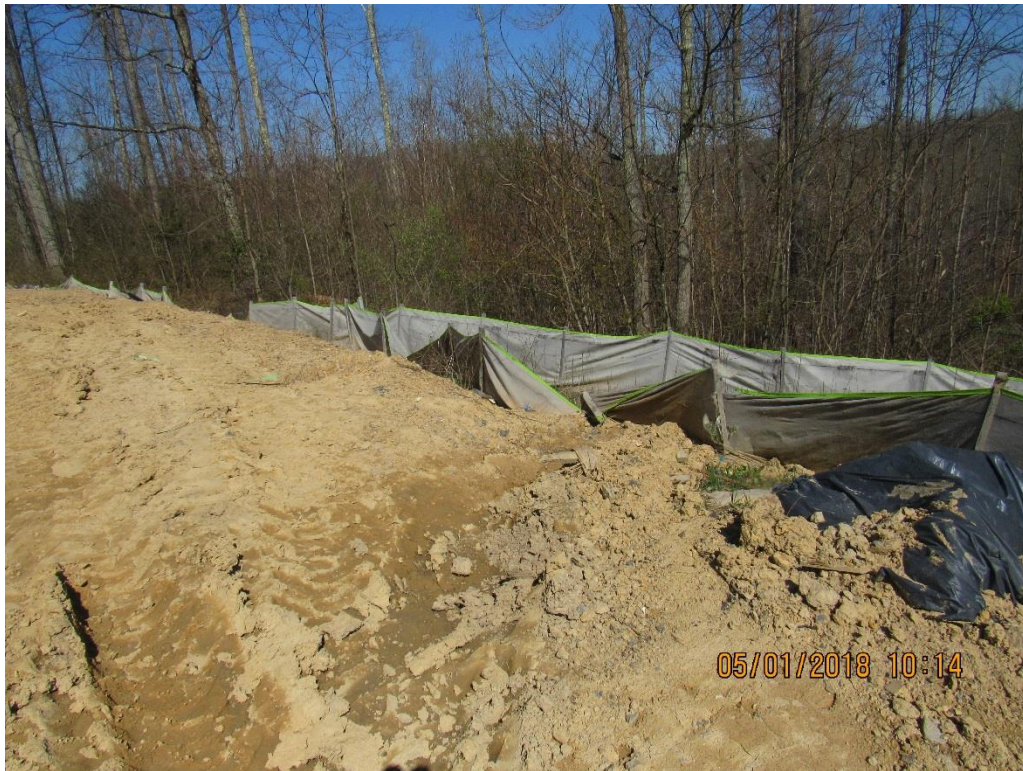
Photo 5: Silt fence needs maintenance and trash is against silt fence.

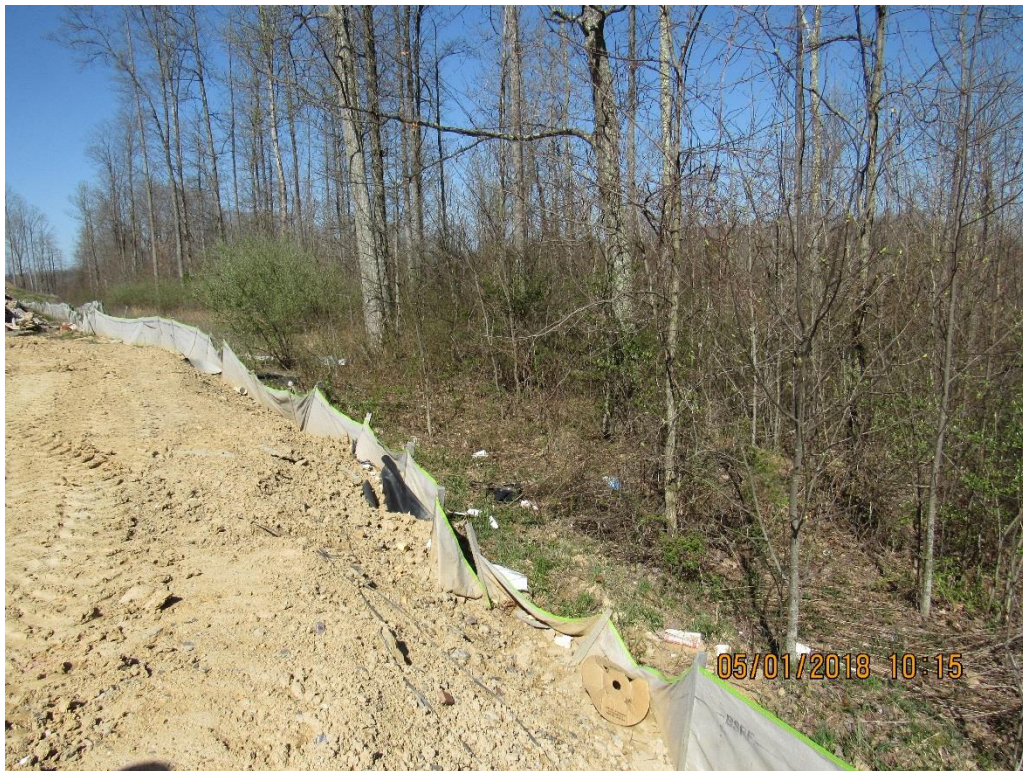
Photo 6: Silt fence needs maintenance and trash is over perimeter fencing beyond LOD.

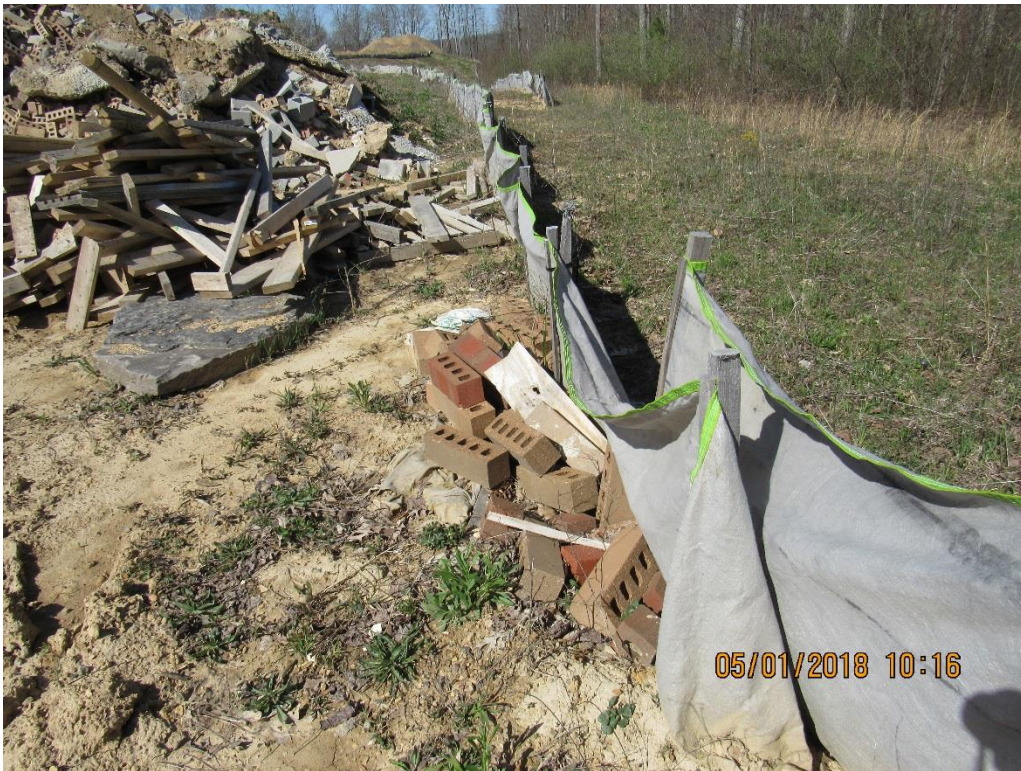
Photo 7: Material (brick and wood) stored against silt fence, which needs maintenance.

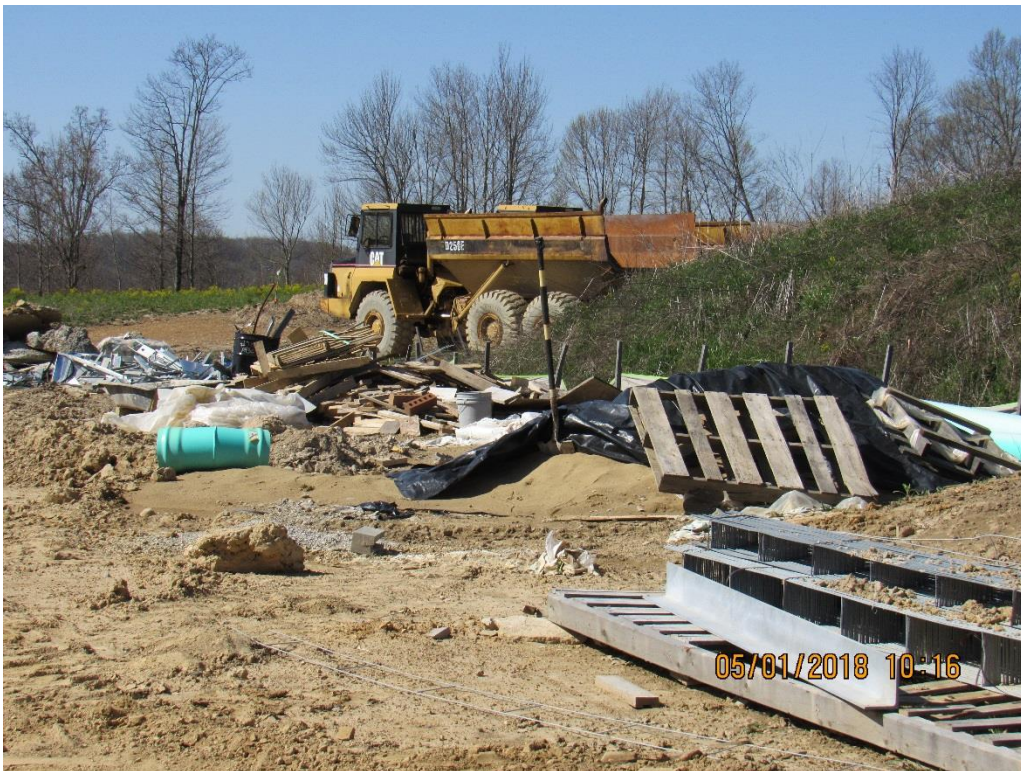
Photo 8: Trash and debris piled in random places throughout the site.

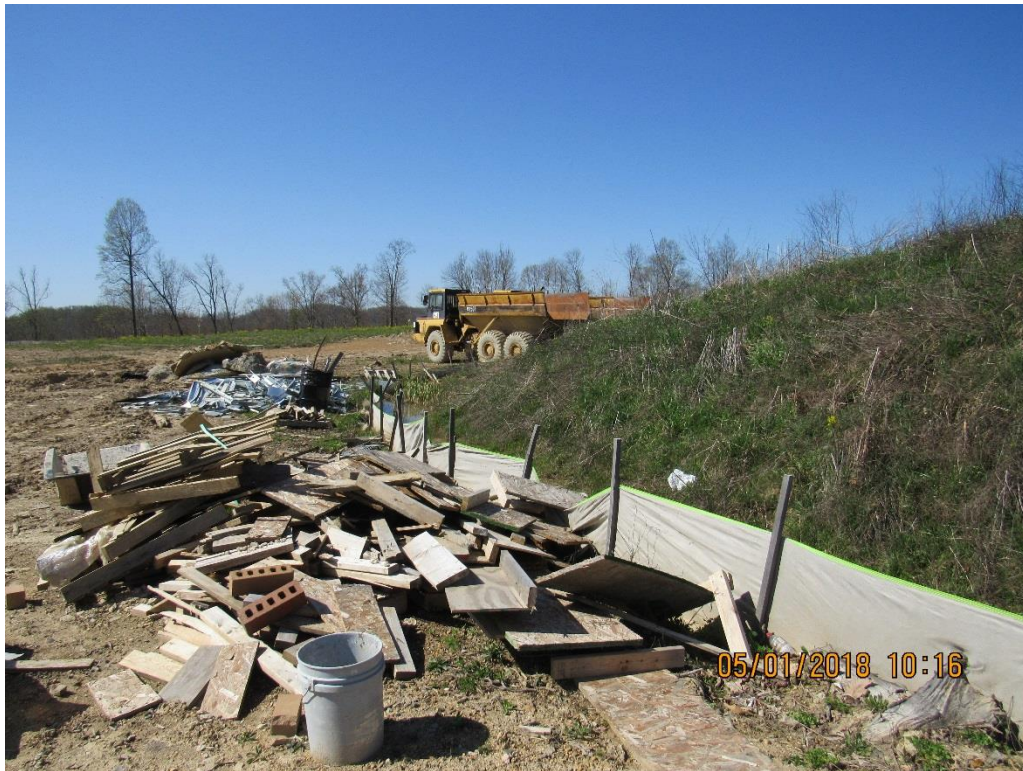
Photo 9: Trash and debris stored against silt fence.

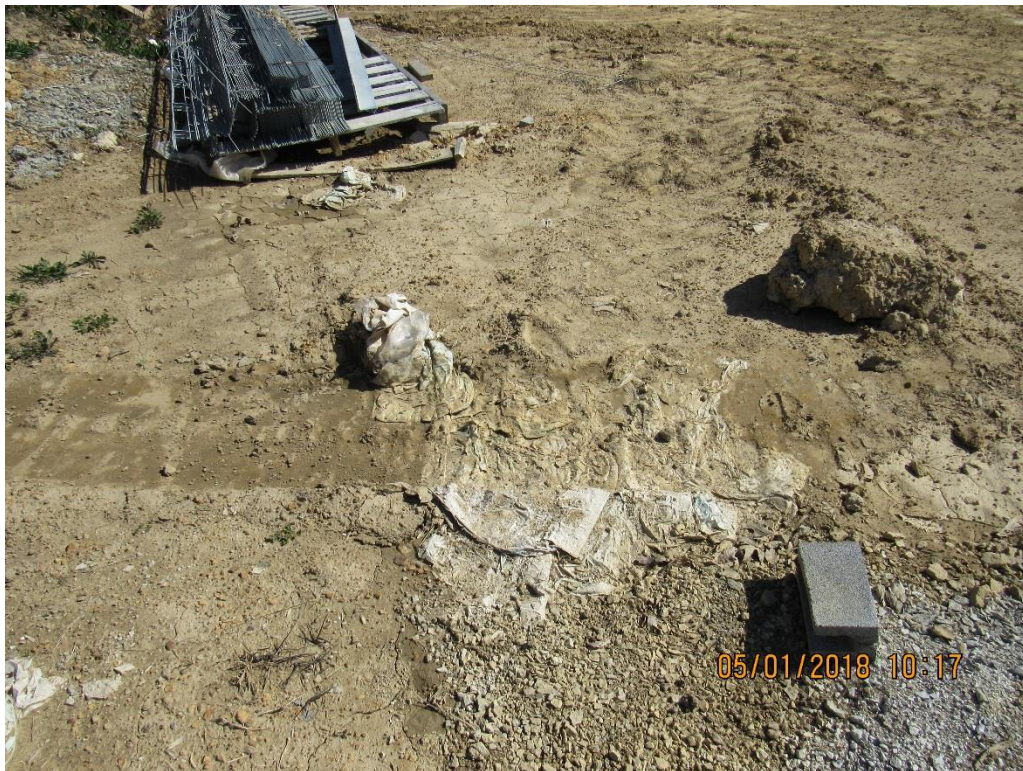
Photo 10: Trash imbedded into dry soil.

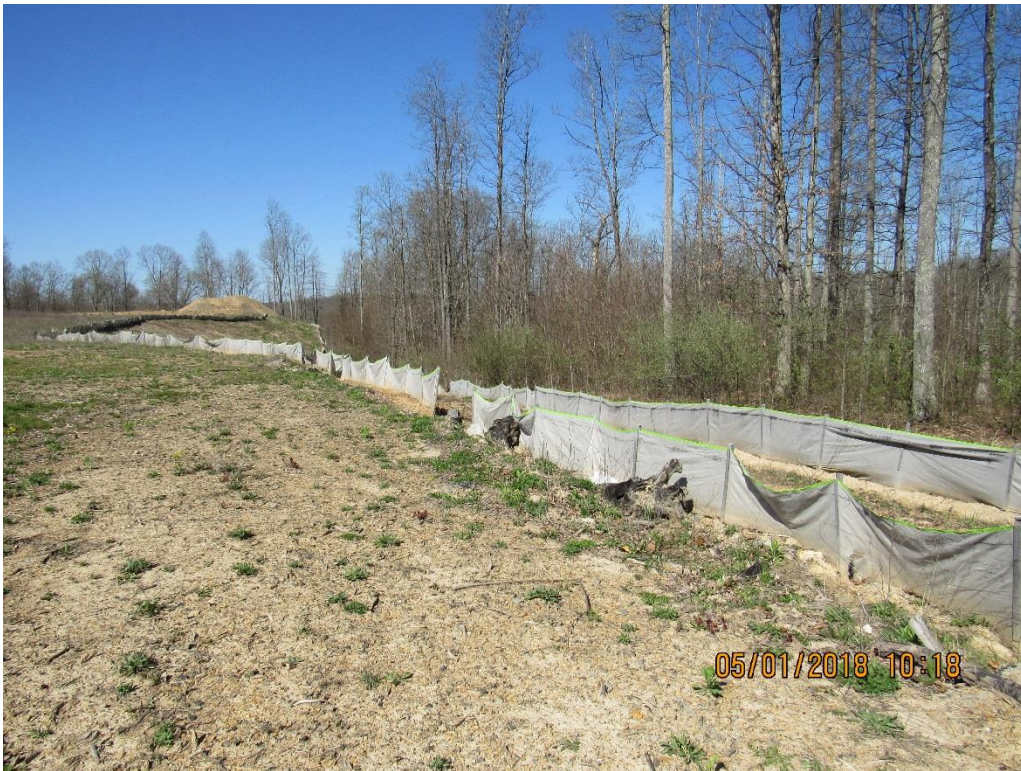
- 6. Maintenance needs performed on all sediment and erosion control devices.
- 8. Temporary stabilization has not been applied to waste pile & temporary topsoil pile. Reseeding – after the initial temporary seed failed to germinate- has not been completed throughout the site. Reseeding on eastern side with permanent stabilization had not been completed. (Photos 11-15 & 24)

Photo 11: Silt fence needs maintenance, trash is against silt fence, and site needs reseeded.

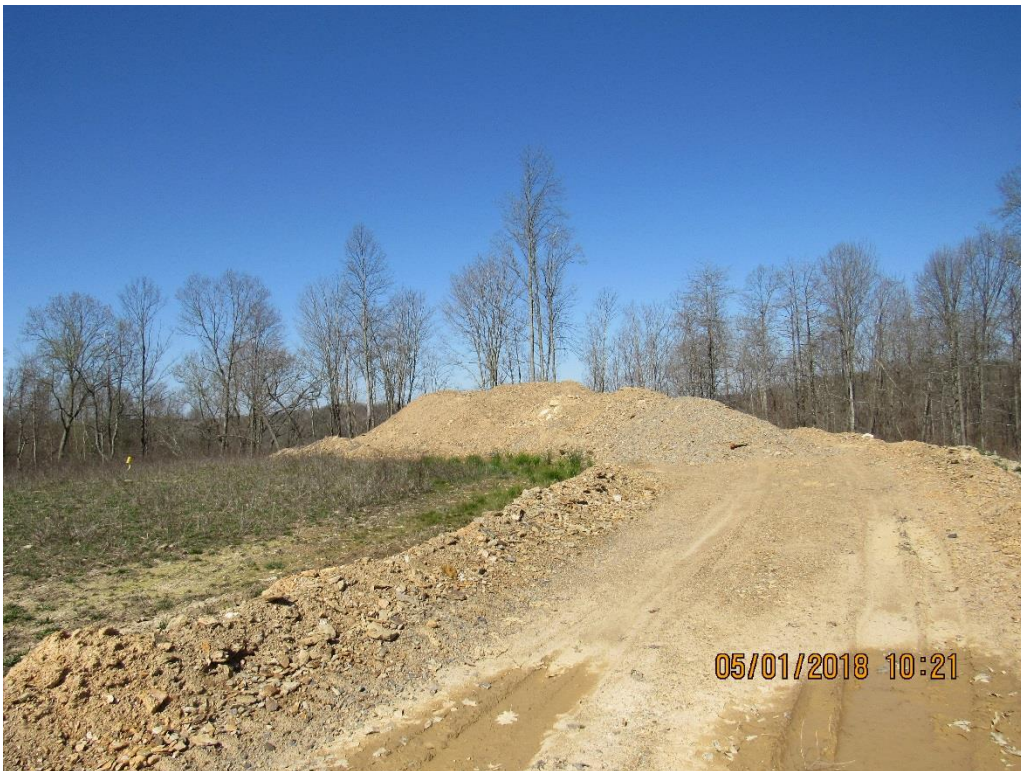
- **Section G.4.e.2.A.i.b. - Permittee has failed to provide interim stabilization on areas where construction activities have temporarily ceased for more than 14 days- on waste material non-working faces. (Photos 12-13)**

Photo 12: Waste stockpile not on plan and does not have temporary stabilization.

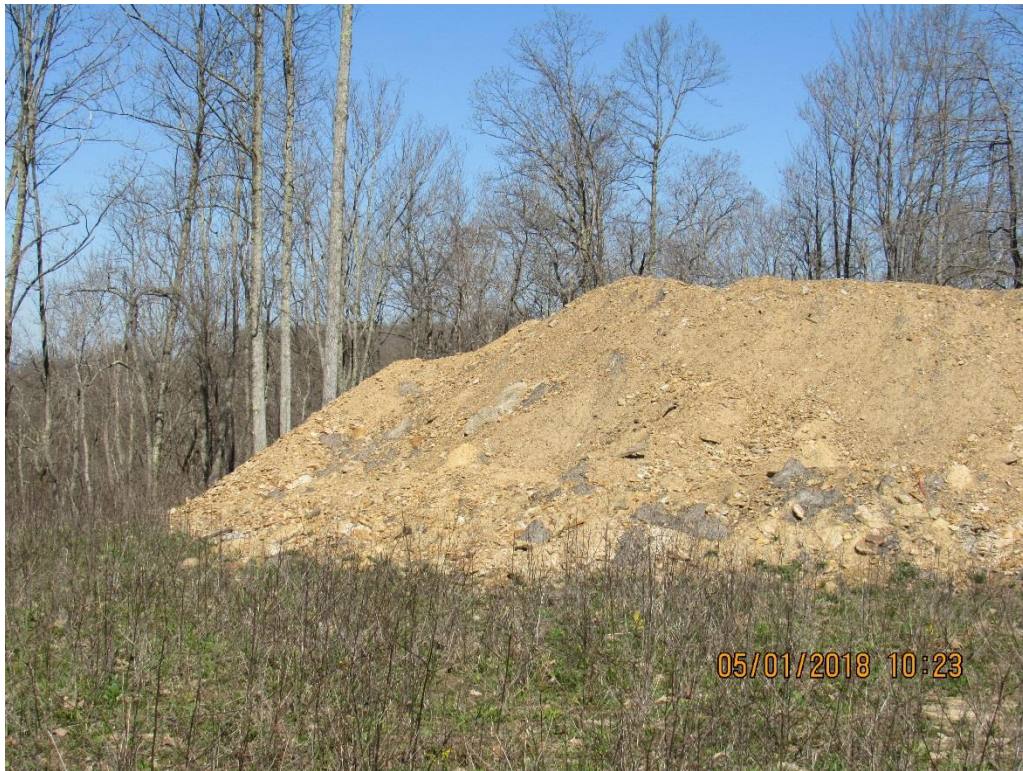
- 5. Waste pile on northwestern side of site did not have temporary stabilization and plan did not indicate placement of waste material. Temporary topsoil pile did not have temporary stabilization installed. (Photos 13 & 14)

- **Section G.4. - Permittee has failed to comply with the General Permit and approved Storm Water Pollution Prevention Plan (SWPPP). Stone ring was not installed at terminus of culvert (Photo 20) which is not allowing adequate settling time to prevent sediment laden water leaving the site and location of waste material was not notated on plan (Photos 13 & 14).**

Photo 13: Non-working side of waste stockpile without temporary stabilization.

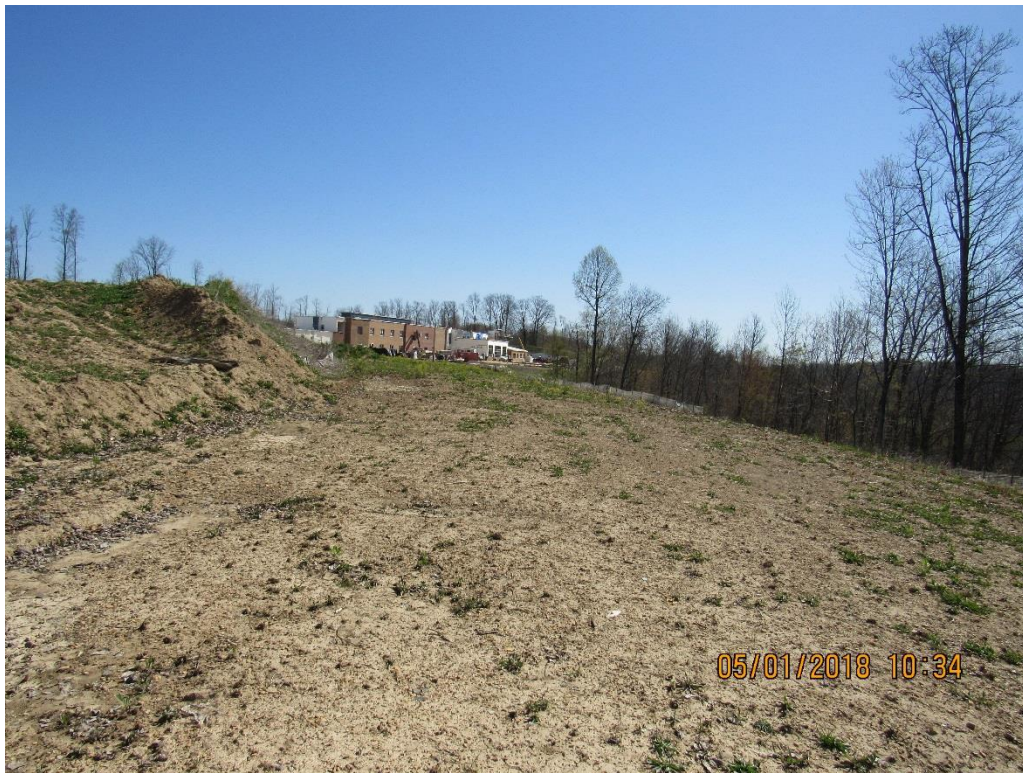
- **Section G.4.e.2.A.i.c. - Permittee has failed to reseed areas that failed to germinate within 30 days after seeding throughout the site including non-working faces of topsoil stockpiles, sediment basin, eastern side of site (permanent cover). (Photos 14, 15, 23 & 24)**

Photo 14: Non-working face of topsoil stockpile which needs reseeded, as well as area around stockpile.

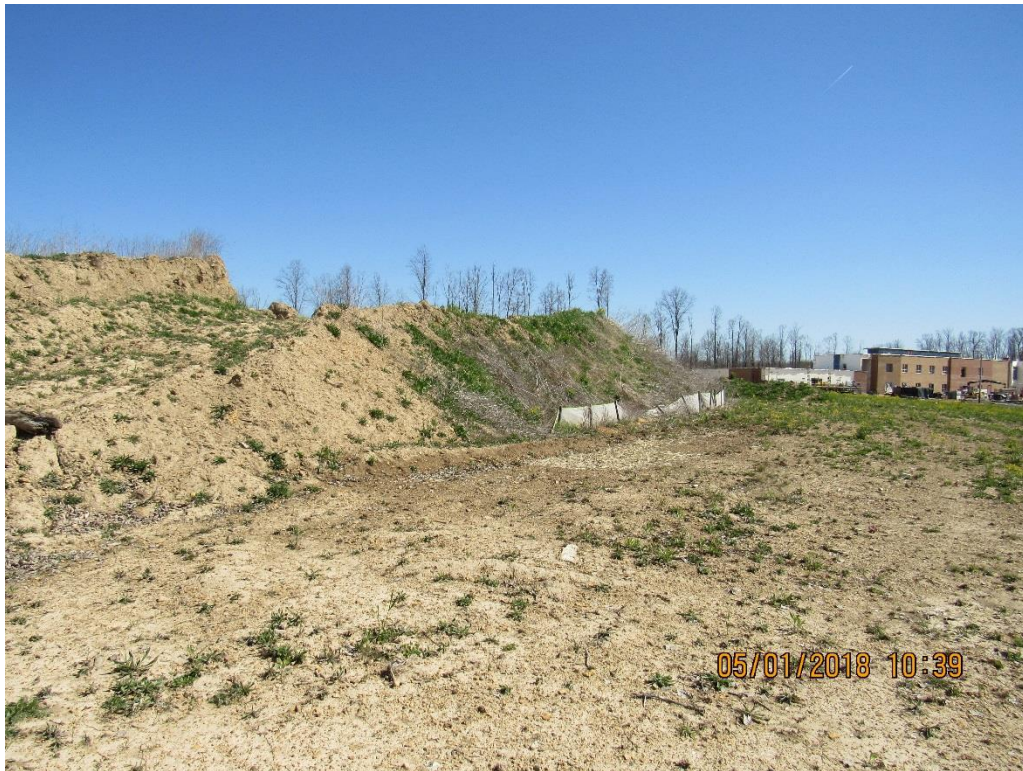
Photo 15: Non-working face of topsoil stockpile and surrounding area which needs reseeded and silt fence needs maintenance.

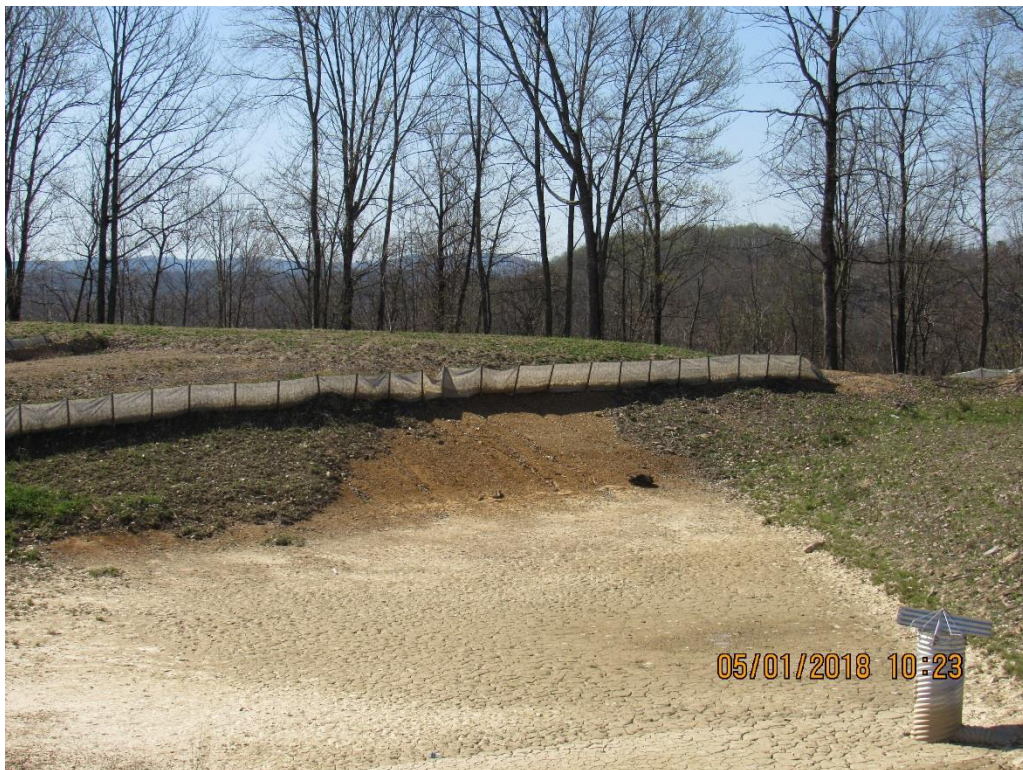
- 3. Sediment basin- stone ring (per plan) was not installed which allowed the basin to short circuit- not allow enough settling time, sides had unprotected inlets from erosion gullies on eastern side, outlet showed evidence of sediment laden water leaving the site and sediment deposits were observed at outlet, on concrete outlet protection and on downslope side of perimeter fencing. (Photos 16, 17 & 20)

- **Section G.4.e.2.A.ii.c. - Permittee has failed to provide inlet and outlet protection for sediment control structure-unprotected inlets caused by erosion gullies observed on south eastern side of sediment basin. (Photos 16-17)**

Photo 16: Unprotected inlets entering sediment basin. (view south)

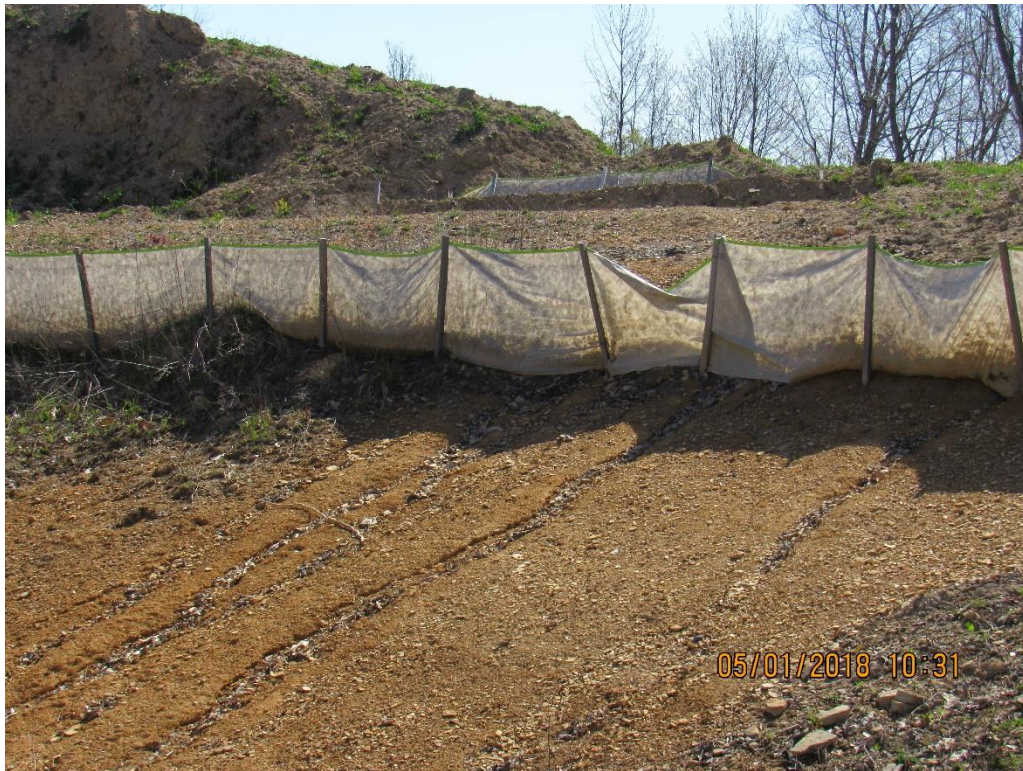
Photo 17: Close-up of unprotected inlets entering sediment basin (view north).

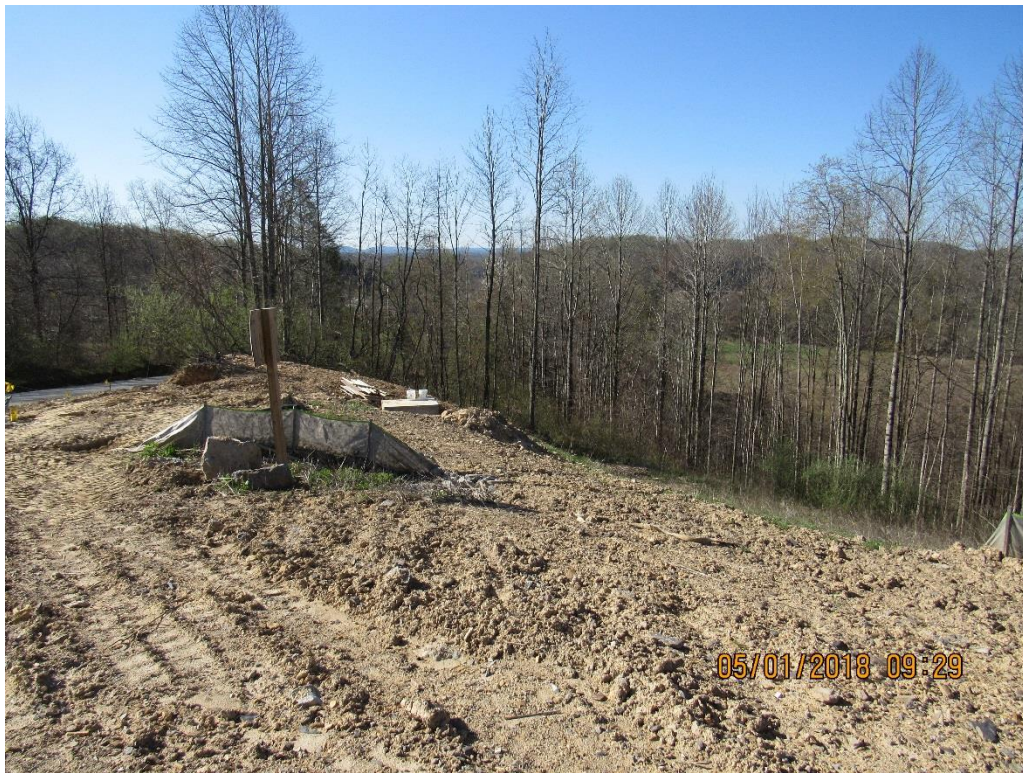
- 13. Appropriate BMP's were not implemented to sufficiently avoid sediment laden water from leaving the site. On north side of site, silt fence had failed, and sediment deposits were observed outside of perimeter fencing. On western side of site, sediment deposits were observed off Limit of Disturbance (LOD) at outlet of basin, outlet of drainage area under amphitheater had no protection. and no controls were installed on the southeastern side of site at location of pad for pump station. (Photos 18 & 19)

- **Section G.4.e.2. - Permittee has failed to properly implement controls: improperly installed and maintained ditch checks, diversion had cuts allowing water to flow over slope instead of at terminus, debris and trash was observed in diversion, ditch checks were not properly installed/maintained (Photos 21-23) and lack of outlet protection at terminus of amphitheater drainage (Photos 25-27), and pump station location did not have any controls installed (Photos 18 & 19).**

Photo 18: No controls installed at installation of pad for pump station.

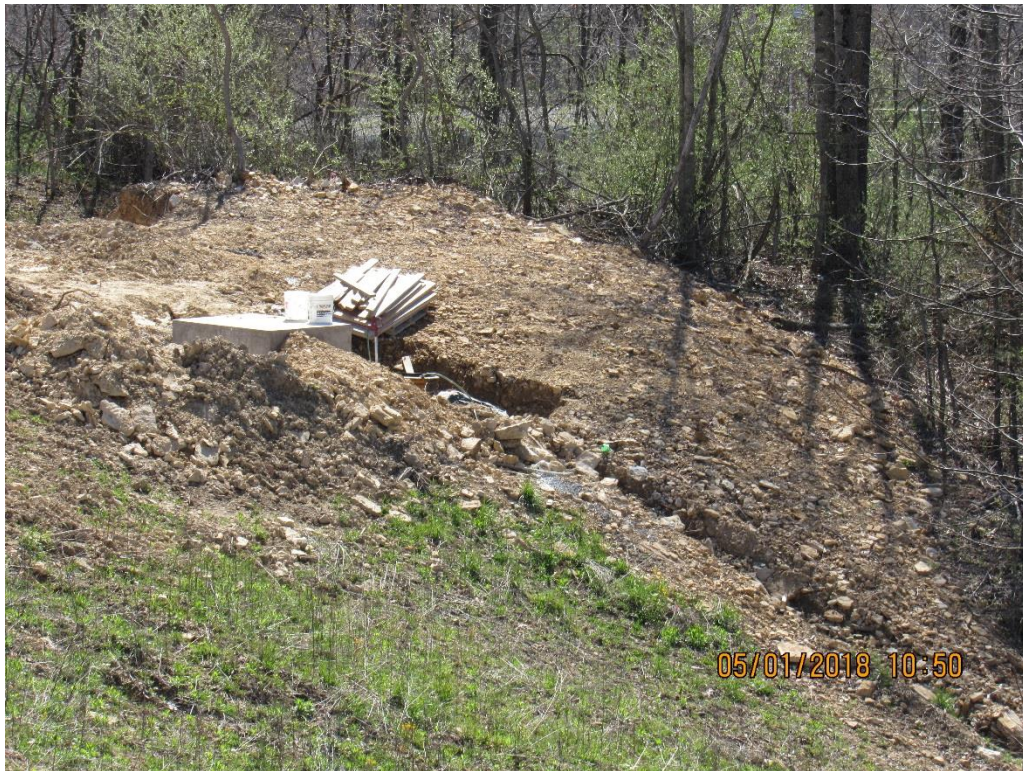
Photo 19: Erosion gully without controls at installed pump station pad.

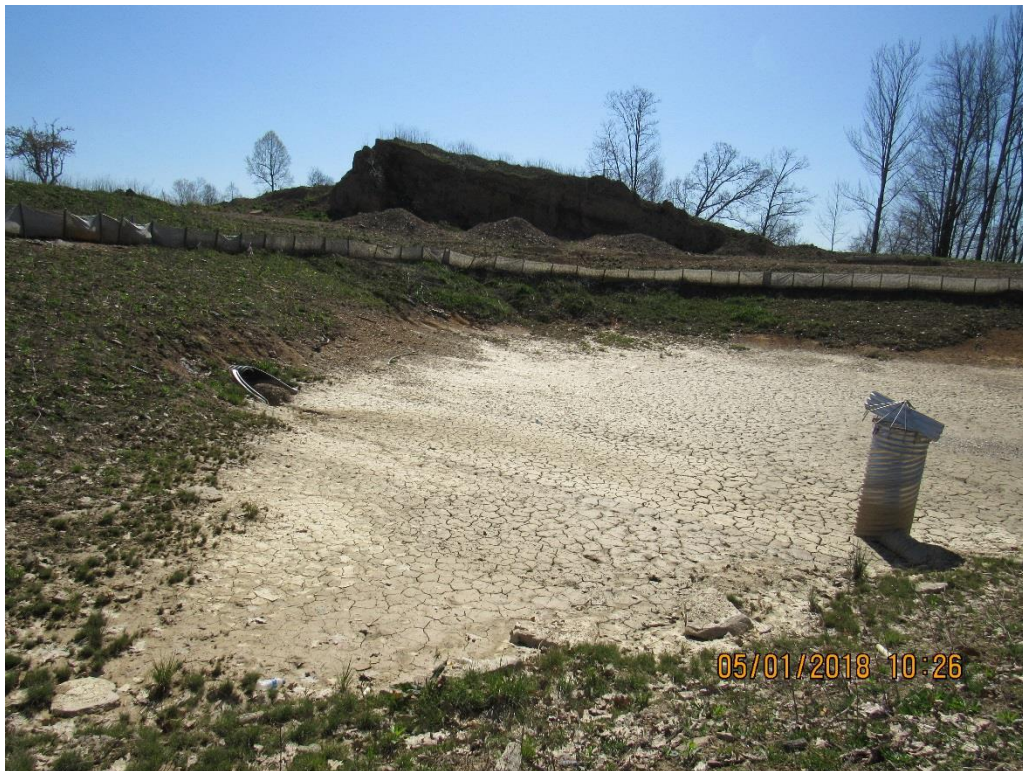
Photo 20: Stone ring (per plan) not installed which does not allow adequate settling time.

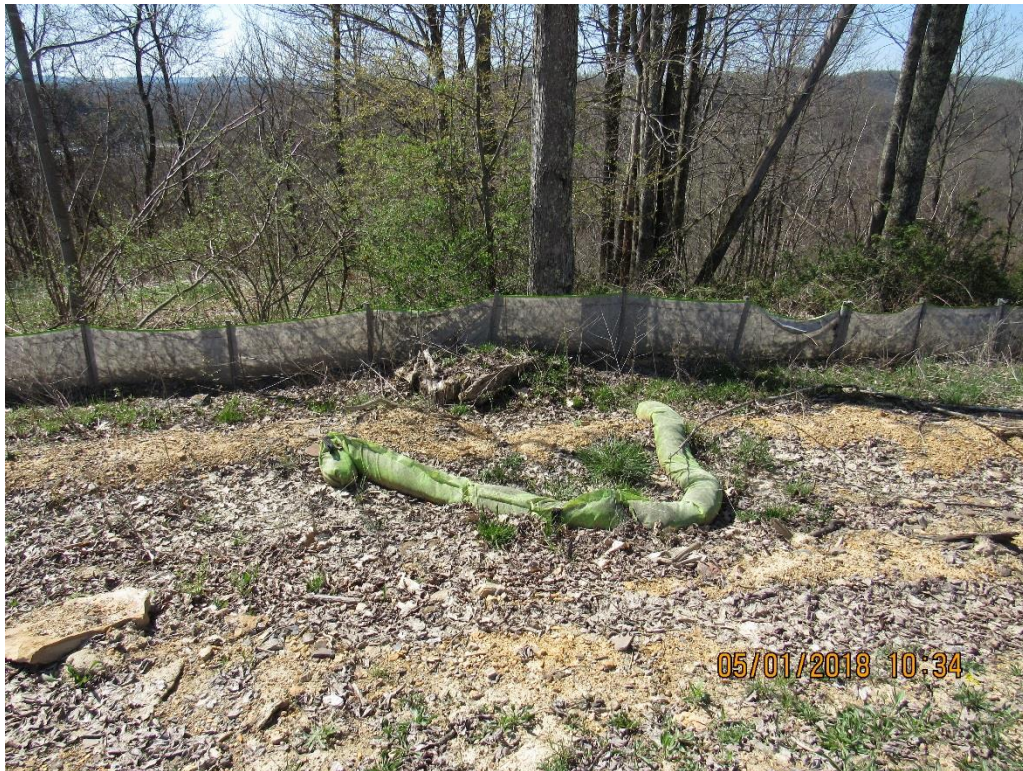
- 2. Diversion & Ditch checks- temporary diversion on south side of project had 2 separate areas where 'cuts' were made sending water over slope instead of at terminus of diversion, debris- trash, logs, and large dirt clods were in the diversion, diversion was not graded to allow adequate drainage per plan, and ditch check (temporary eel) were not installed correctly. (Photos 21-23)

Photo 21: Improper installation of ditch check- on west side of site.

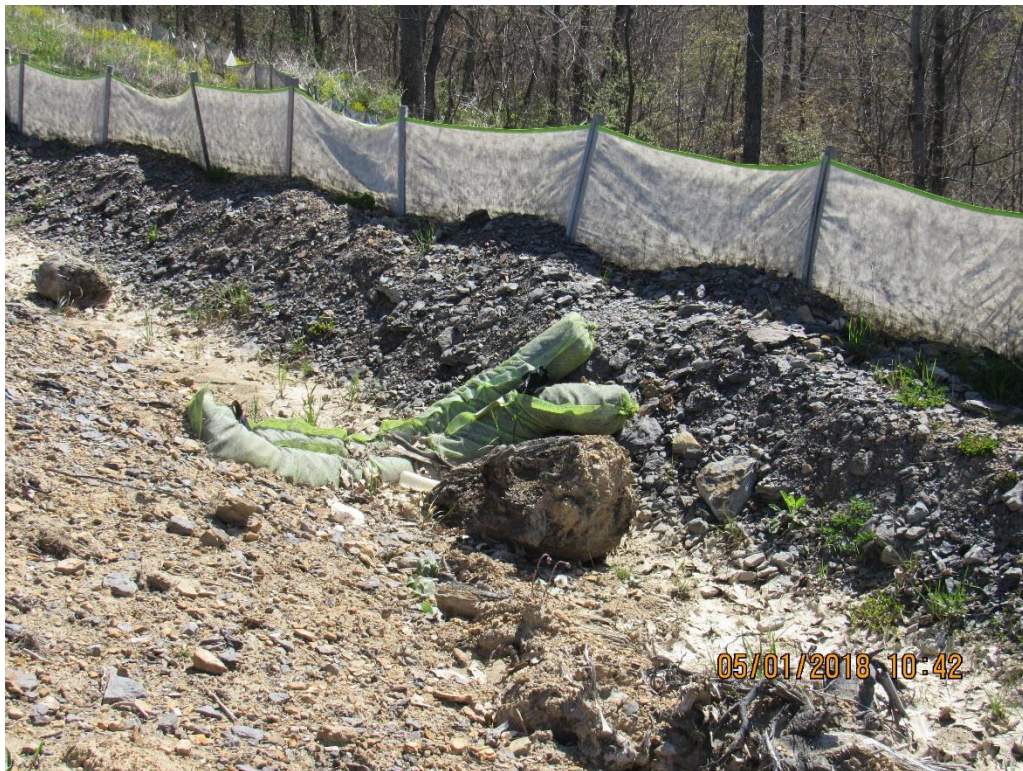
Photo 22: Improperly maintained ditch check with debris in diversion.

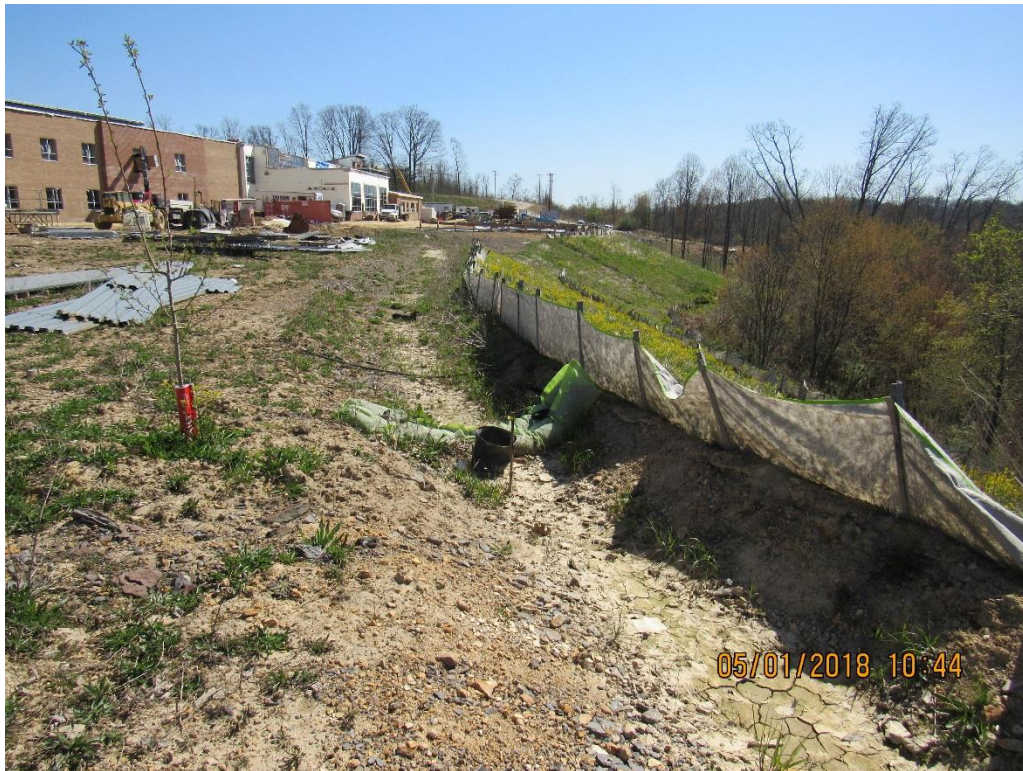
Photo 23: Improperly maintained ditch check- trash located in diversion and reseeding needed.

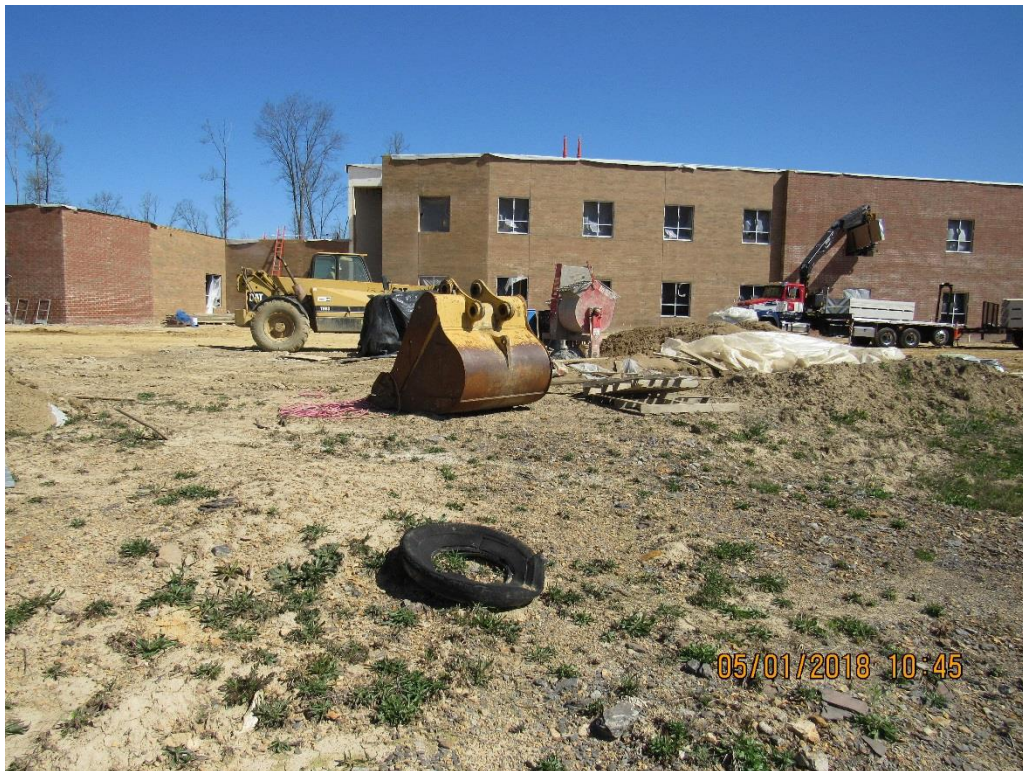
Photo 24: Reseeding needed and trash randomly around site.

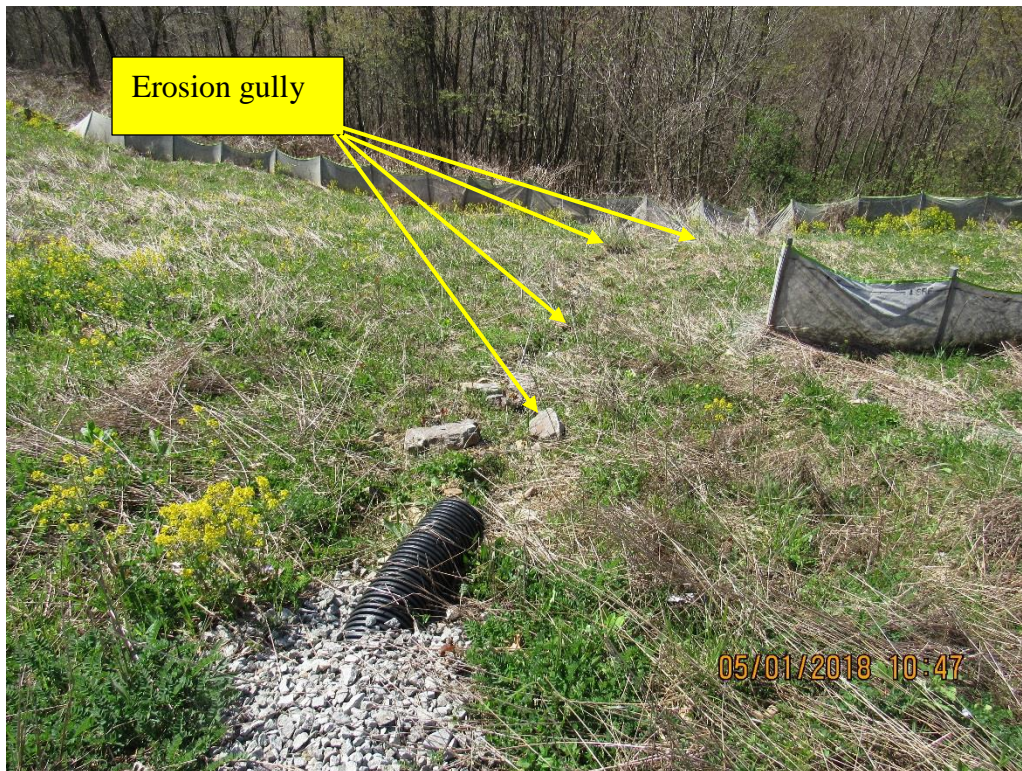
- 14. Southern slope was left unprotected in several areas creating erosion gullies. Diversion ditch was inappropriately cut to allow water to flow uncontrolled down slope, outlet from drainage area under amphitheater had no protection allowing water to flow uncontrolled down slope, location of pump station pad had no controls with sediment delta at terminus. (Photos 25-27)

- **Section G.4.e.2.A.ii.f. - Permittee has failed to protect fill slopes-outlet to amphitheater drainage was not protected and 'cuts' were made into diversion ditch sending water down slope without protection. (Photos 25-27)**

Photo 25: Unprotected outlet of amphitheater drainage creating erosion gully along slope.

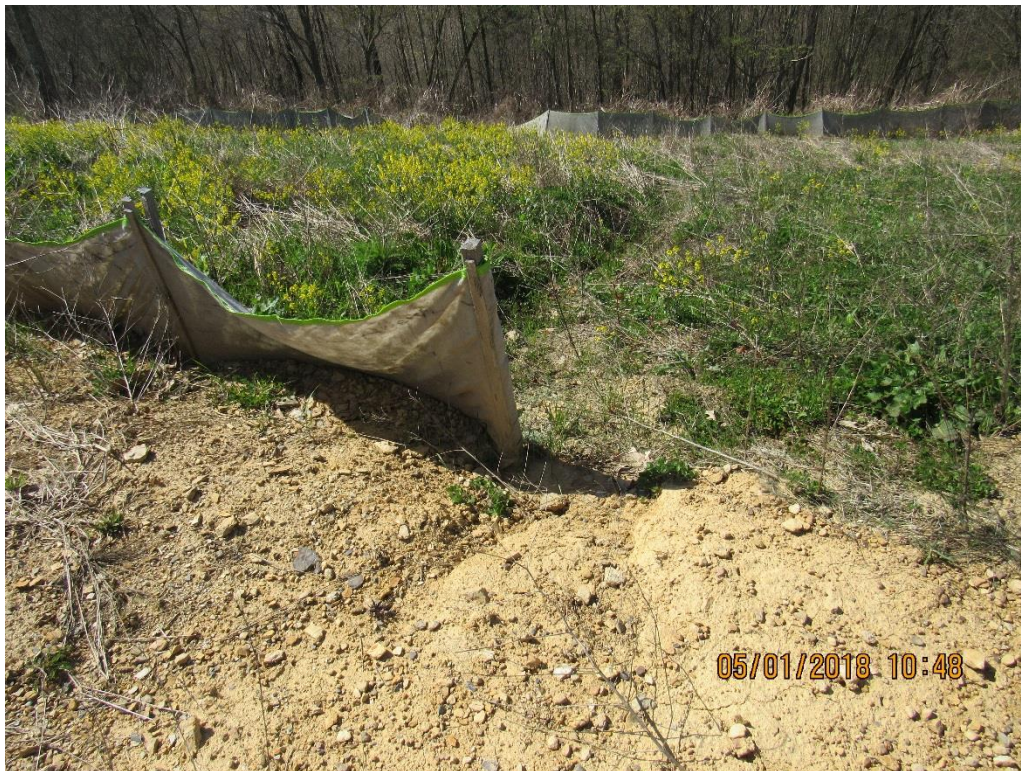
Photo 26: Silt fence near amphitheater needs maintenance creating erosion gully over slope (view top of slope).
